## Memorandum

Re: Summary of Field Oversight: LPR River Mile 10.9 Initial SPME Reconnaissance  
(April 20 to 21, 2015)  
Lower Passaic River Restoration Project

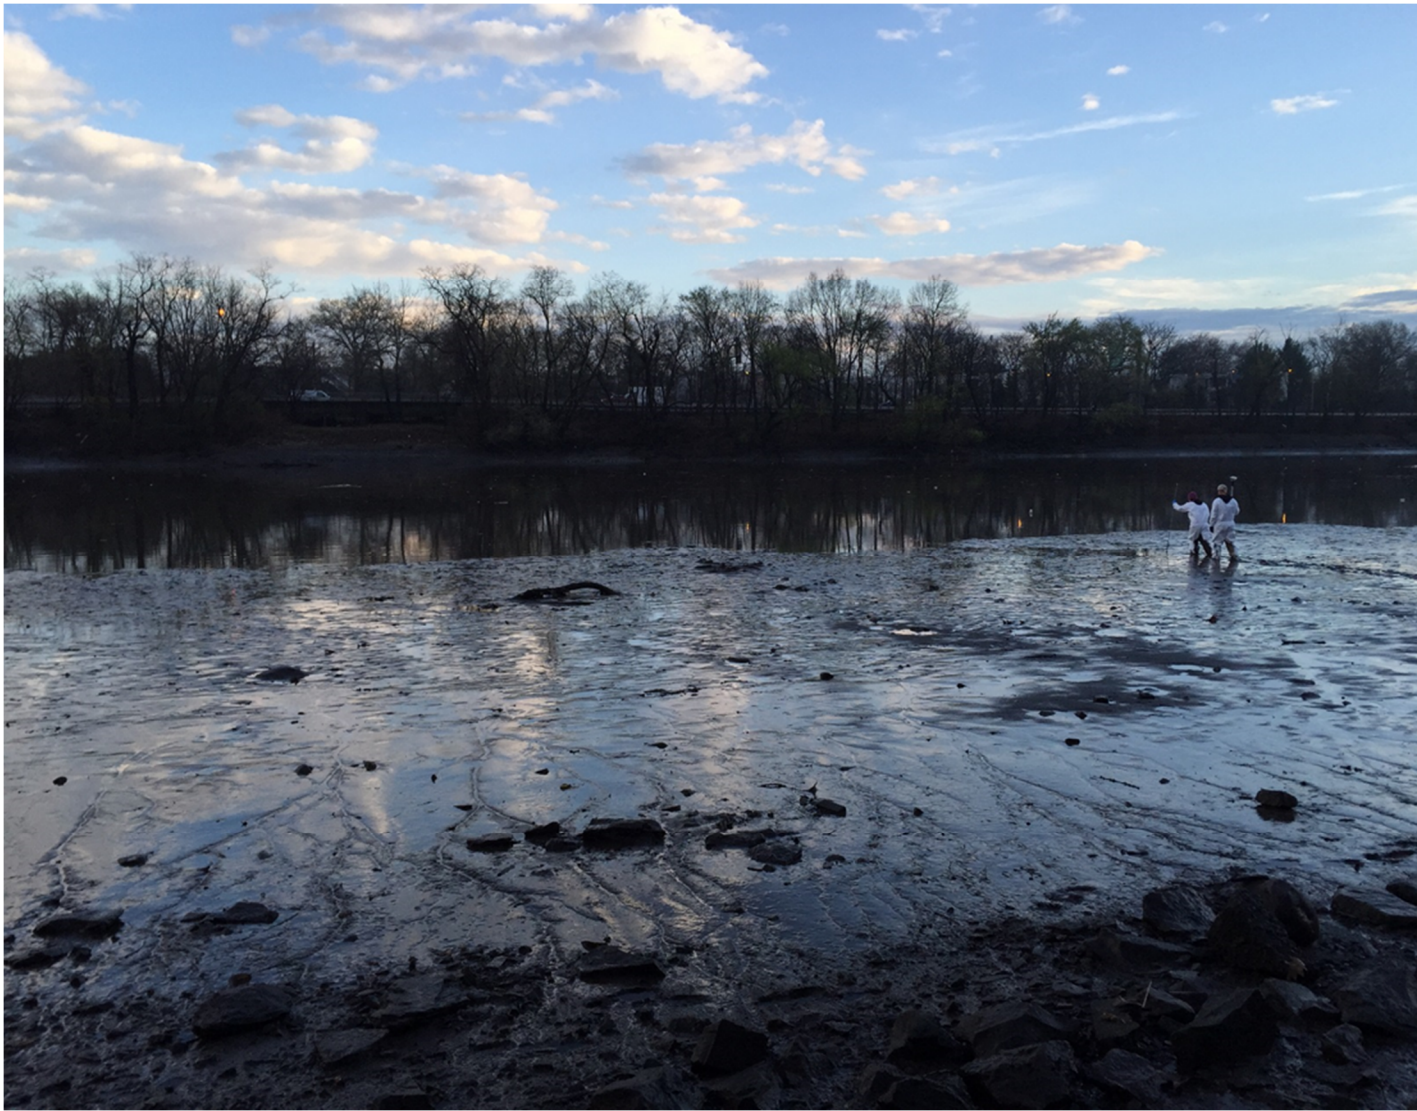
**Photo 1 - Accessing Proposed Location 5  
(4/21/2015)**

Probing rod for gauging thickness of habitat  
layer/silt overlying armor layer

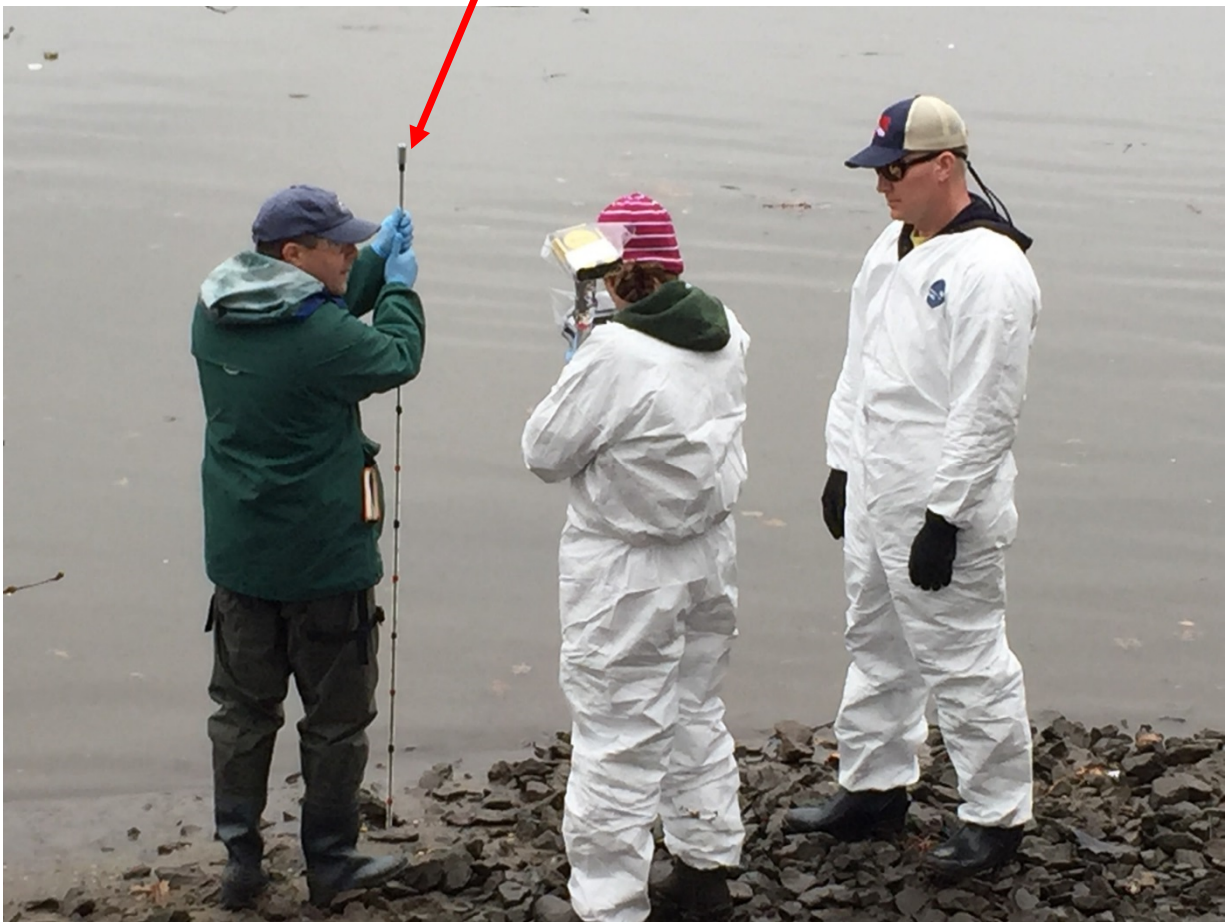
**Photo 2 - Probing Rod and GPS'ing of Location  
(4/20/2015)**

As the majority of the proposed sample locations could not be reached in the dry during the field activities, the thickness of the existing cap layers at these locations could not be determined. However, areas that were exposed during the low tide were probed to determine the layer thickness at those locations. In general, the sand and/or silt layer overlaying the armor stone was approximately 6 to 12 inches thick. It is unknown at this time whether this layer was composed of the original sand habitat layer, deposited silt from the river, or some combination of the two. A surficial sediment sample (top six inches) was not collected from the habitat layer during the field effort, as was indicated by the workplan, for unknown reasons. This habitat/silt layer thickness was assessed by pushing a marked probing rod (see Photo 2) through the top of the exposed sand/silt surface until refusal was encountered at the top of the armor layer.

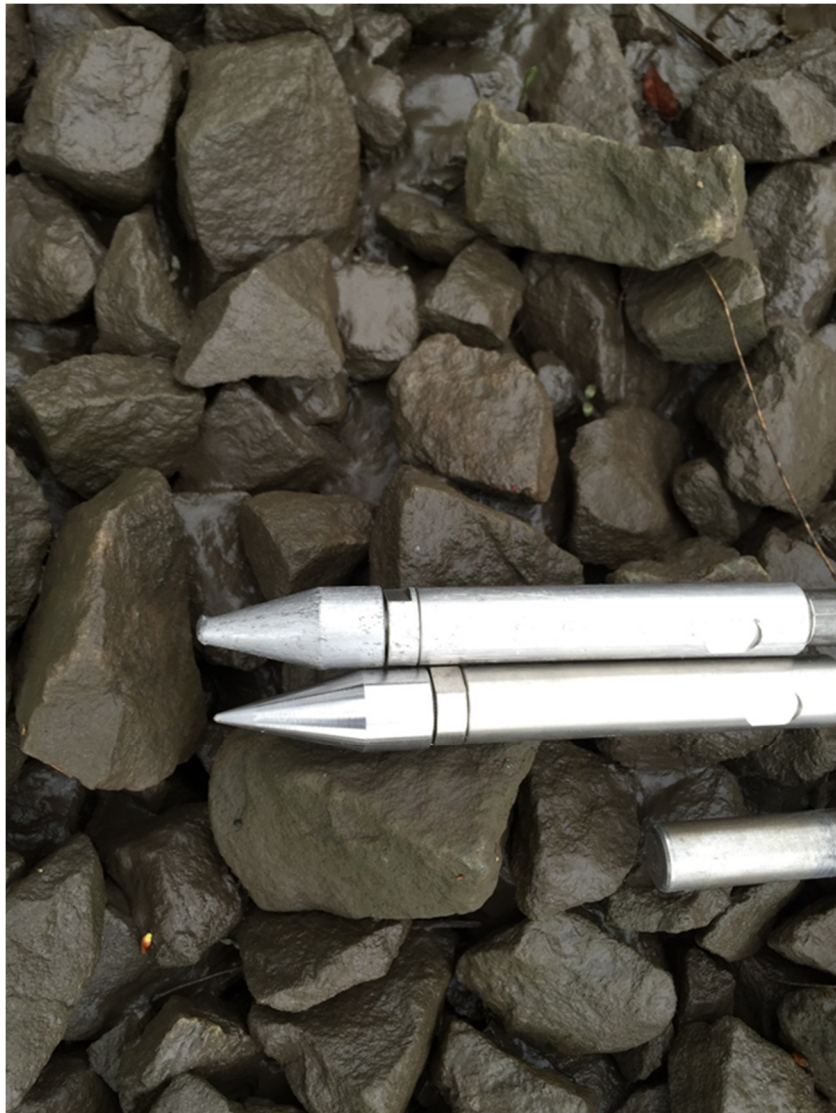
**Photo 3 - AMS Soil Vapor Probe Before (bottom) and After (top)  
Penetration of Armor Layer  
(4/20/2015)**

The probe used to gauge the thickness of the sand layer was unable to penetrate the top of the armor layer underlying the surficial sand and silt at each location. As a result, an AMS soil vapor probe with a pointed tip (see Photo 3) was used to attempt to penetrate the armor layer and the geotextile underlying the armor layer. However, penetration could not be achieved by simply pushing the probe downward. A slide hammer was necessary to drive the point through the armor layer and the geotextile underlying the armor layer (Photos 4, 5, and 6). The armor layer thickness overlying the geotextile was then estimated to be the distance between a.) where the probe rod originally encountered refusal and b.) where the slide hammer-driven point encountered significantly less resistance during insertion (the thought process being that once the armor layer and geotextile was penetrated, the underlying active layer would offer significantly less resistance to penetration). Based on field observations of the locations that were probed, the thickness of the armor layer was approximately 12 inches, with minor variations of a few inches thickness at the various locations.

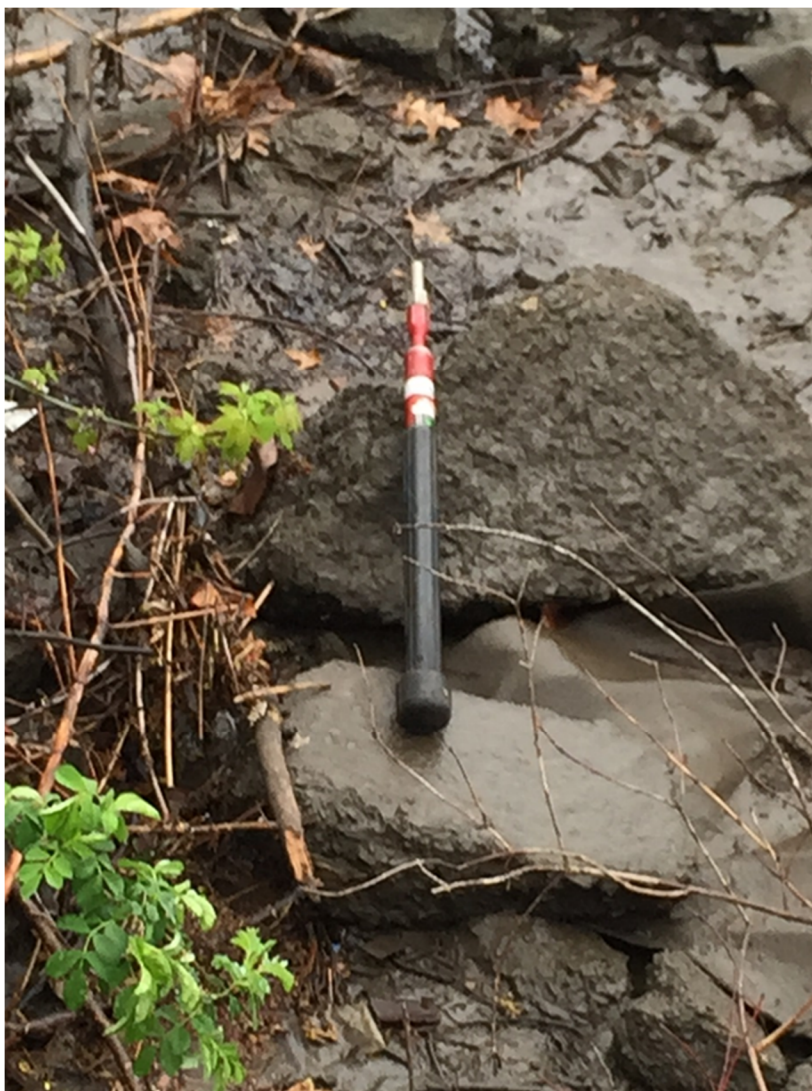
**Photo 4 - Slide Hammer used for Inserting AMS Soil Vapor Probe  
through Armor Layer  
(4/20/2015)**

The AMS Soil Vapor probe, driven by a slide hammer, was able to penetrate through the armor stone and into the active cap layer. AECOM suggested that the soil vapor probe could be driven through the armor stone to the desired depth, the sample screen at the probe tip could be exposed, and a SPME sampler could be inserted through the top of the hollow stem of the sampler down to the exposed screen interval (Photos 9 and 10 present two types of AMS soil vapor probe screens). This sampler arrangement would remain in place until the conclusion of the sampler deployment period. If this approach were taken, measures preventing surface water or precipitation from entering the top of the hollow stem would be required in order to prevent these waters from potentially diluting the porewater entering the sampler through the screen. SPME fibers were not placed into the soil vapor probe prior to it being driven through the armor layer as the exact SPME fiber deployment technique is not yet known.

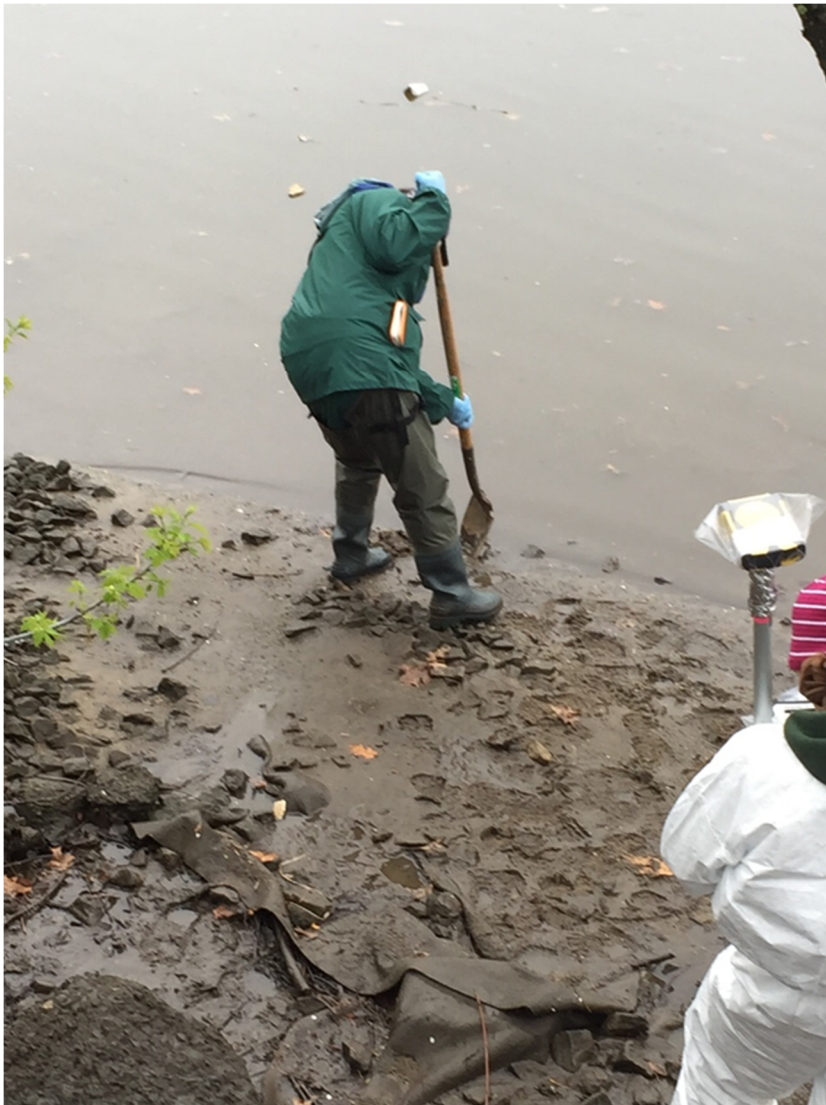
**Photo 7 – Attempt to Remove Armor Layer with Shovel  
(4/20/2015)**

The thickness of the active layer underlying the armor layer could not be assessed using a core tube due to the thickness of the armor stone layer and the inability of the core tube to penetrate the armor layer. An attempt was made to remove armor stone with a shovel; however, the armor stone could not be easily removed in this manner (Photo 7). Techniques to assess or estimate the active layer thickness will have to be developed before the field mobilization for the baseline monitoring event.

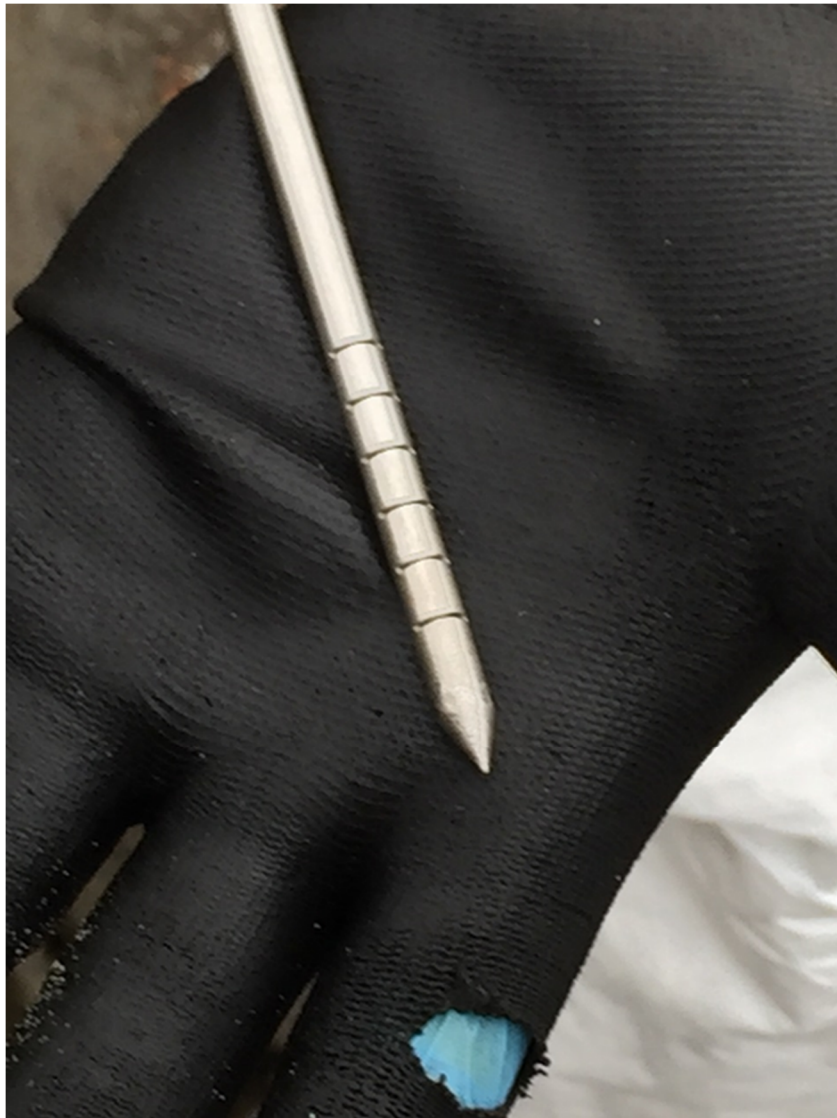
**Photo 8 – Henry Push Point Sampler  
(4/20/2015)**

AECOM attempted to advance a Henry Push Point sampler (Photo 8) through a portion of exposed geotextile near the riverbank. The Henry sampler was unable to penetrate the geotextile without significant “bowing” of the sampler. Based on this observation, it is unlikely that the Henry sampler would be able to penetrate both the armor stone layer and the geotextile without significant physical deformation of the sampler. The armor stone layer at the proposed sampling locations would likely have to be removed if Henry samplers were selected for use.

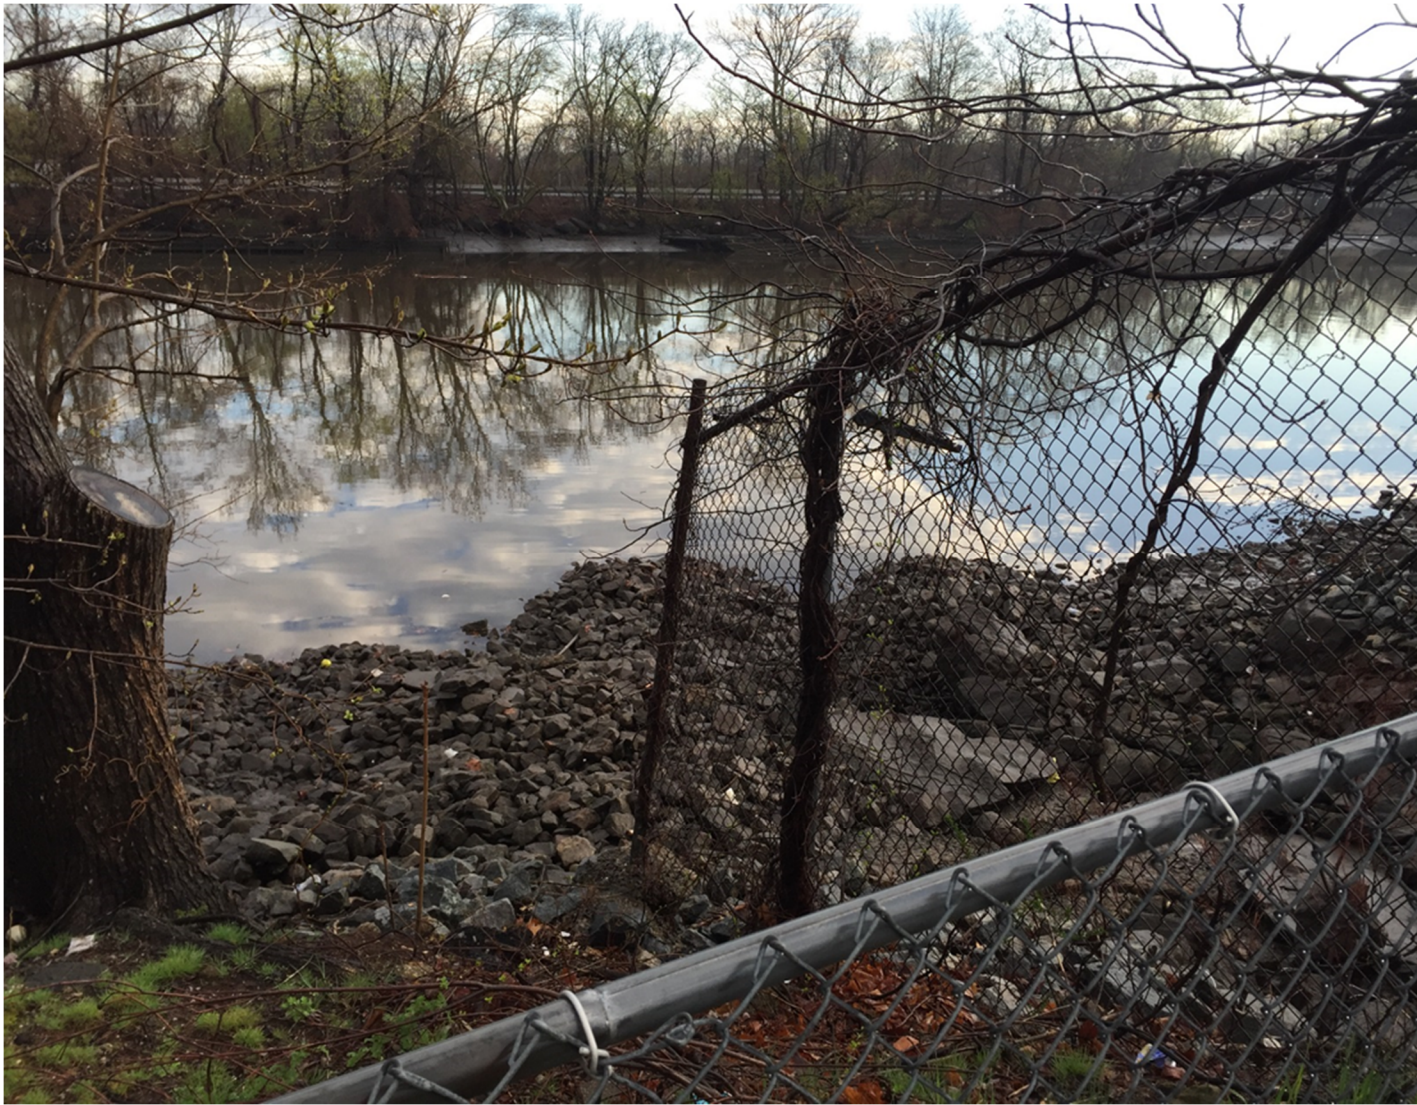
**Photo 11 – Armor Stone at Northern Portion of Cap Near Outfall  
(4/21/2015)**

During the visual inspection of the proposed sampling sites, armor stone of an apparent increased size and thickness (as compared to the few exposed armor stones at other cap locations) was visible near the northern most portion of the cap (Photo 11). This area was not accessible by foot. This armor stone was apparently placed to avoid erosion of the cap from an outfall at that location. Penetration of the armor stone layer at this location may be difficult, even with the slide hammer-driven probe. An alternate sampling location having similar physical and chemical characteristics as this location should be selected as a contingency.
